FRACTOGRAPHIC ANALYSIS OF OPTICAL FIBERS

**J.J. Mecholsky, S.W. Freiman and S.M. Morey
Naval Research Laboratory
Washington, D.C. 20375**

November 1977

Interim Technical Report 1

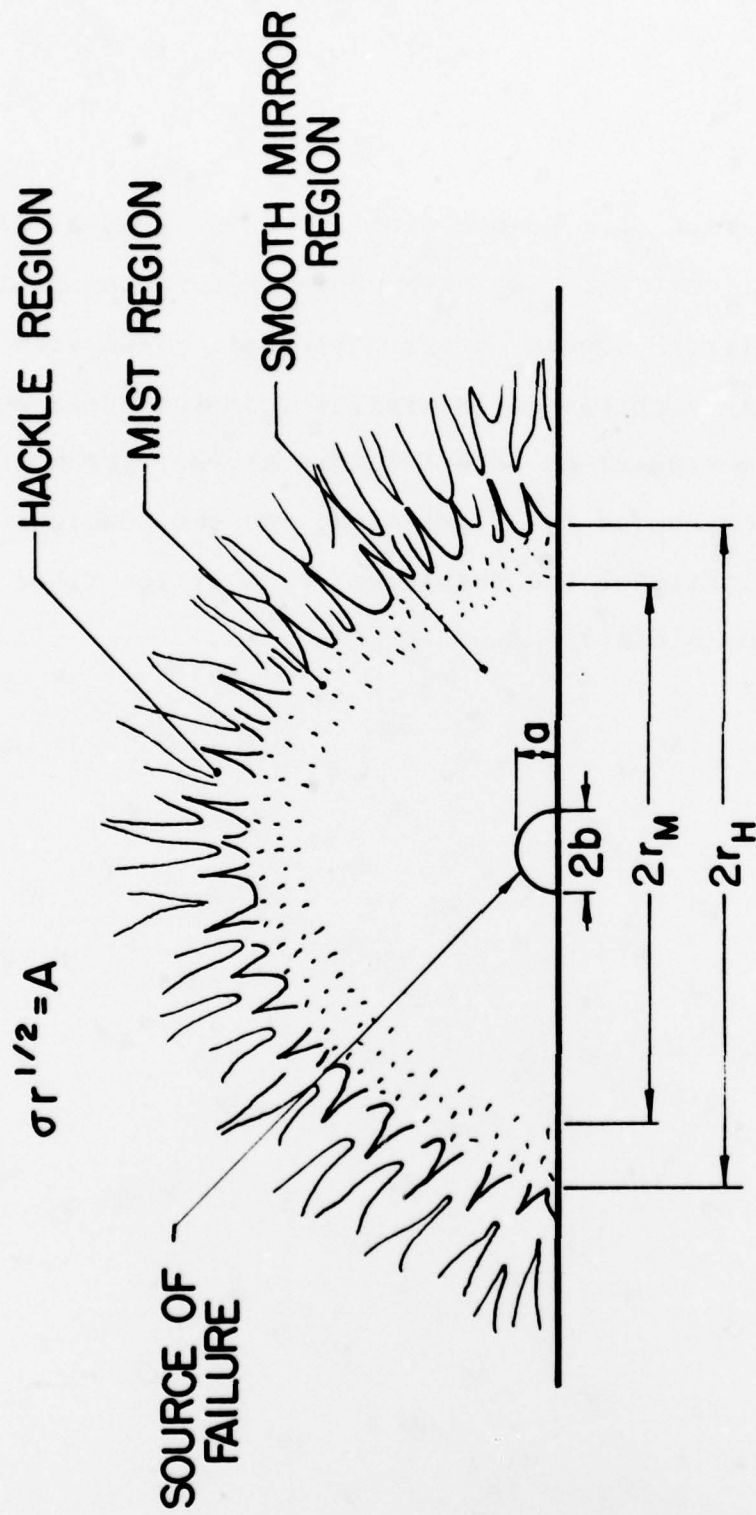
Four definitive regions surrounding fracture initiating flaws^{1,2,3} in silicate and non-silicate glasses have been observed (Fig. 1). The mirror (a flat smooth region) is bounded by the onset of mist (a region of small radial ridges) which is bounded in turn by hackle (a region of larger radial ridges) which is bounded by macroscopic crack branching. It has been extensively demonstrated that the products of the strength, σ , and the square root of the distance from the origin to the onset of: mist (i.e., the mirror radius, R_m), the onset of hackle (R_H) and of crack branching (R_B) give three constant values for silicate glasses:

Fig. 1. Schematic of fracture origin showing idealized semi-elliptical surface flaw and surrounding fracture features known as mirror, mist, and hackle. Crack branching is beyond the hackle.

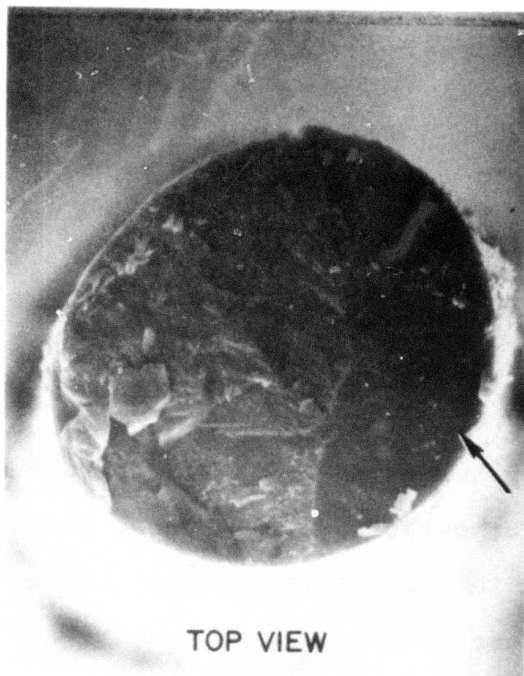
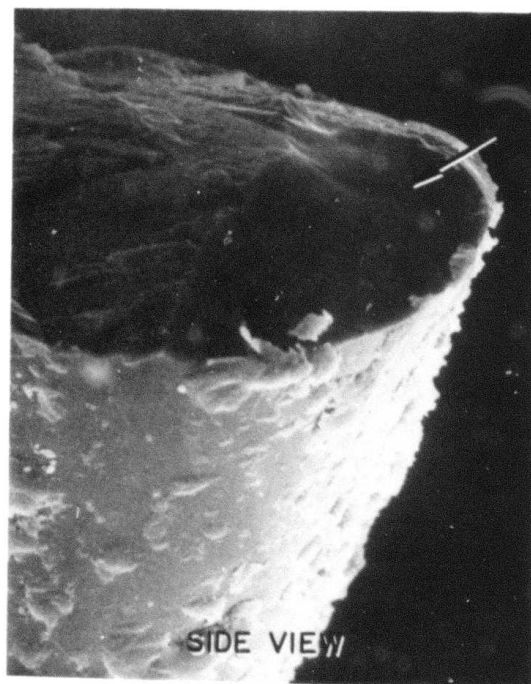
Observation of fracture surfaces on brittle materials and in particular on fibers can be misleading unless one can determine that the origin is real and is primary, that is, the main cause of failure. For example, if one observes the top view in Fig. 2 it could be concluded erroneously that a relatively large somewhat irregular mirror exists surrounding the origin. However, if care is taken to get another angle of observation (side view) one sees that in reality a chip out of the fracture surface is being observed. A true fracture mirror in most cases would not deviate from the total plane of fracture as much as indicated in the figure.

Fig. 2. SEM fractograph of a Hughes fiber (770209- H-SS-3) after removal of metal coating. Top view shows appearances of irregular "fracture mirror" around "origin" (arrow). Side view shows this to be really a chip that is missing from the surface (arrow) giving the false appearance of a fracture mirror. From the fracture markings beyond this lost area, one can conclude that a surface defect initiated the fracture. (The silica fiber is nominally 120 μm in dia.).

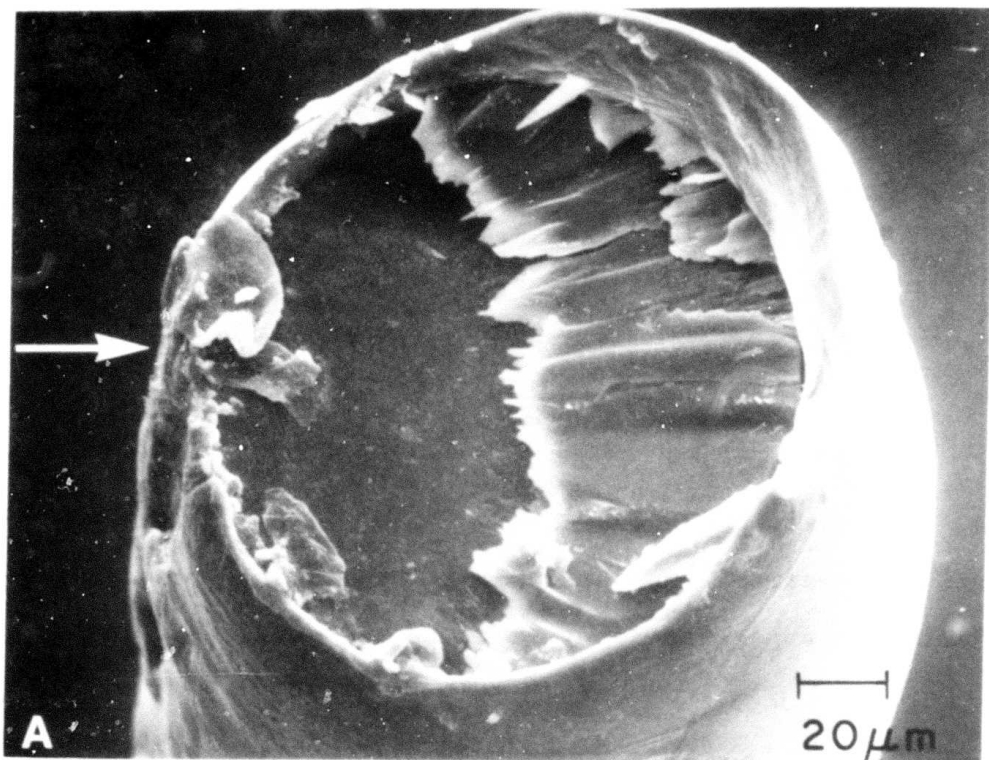
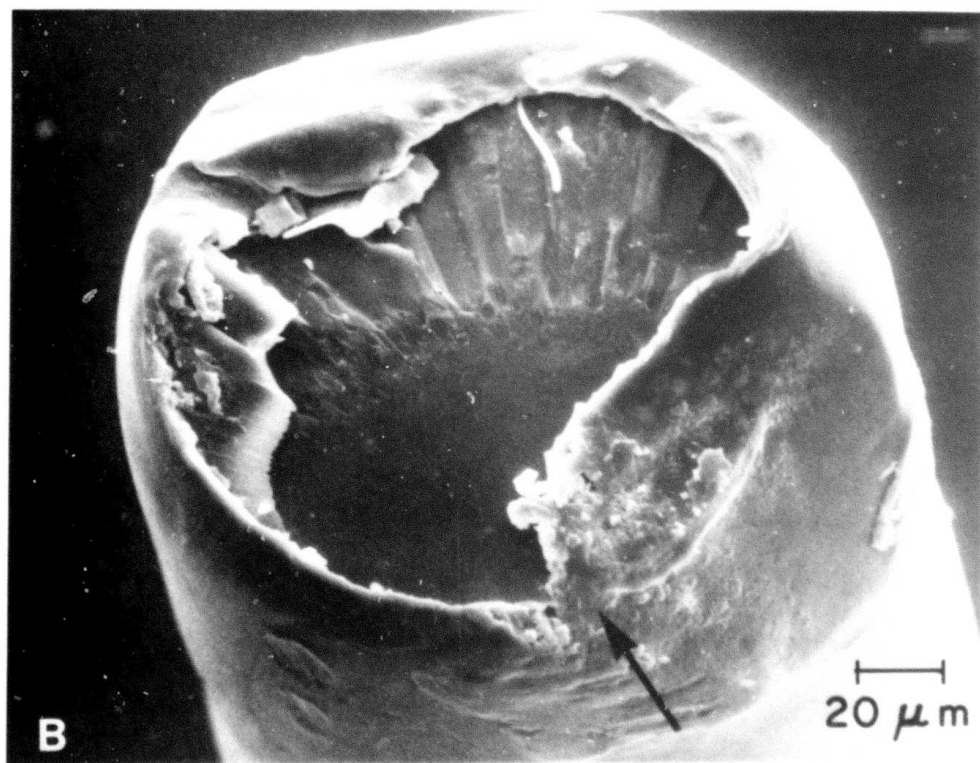
Table I summarizes the 25 Hughes fibers examined to date. Note that even when origins could not be determined, fracture markings pointed back to the area of the origin, indicating whether a surface or internal origin was the source of failure. An example of this is shown in Fig. 3 where the origin is covered by aluminum but the markings clearly indicate that a surface origin was the cause of failure even though the exact origin, i.e. whether it is a crack or a dust particle, etc., is not clear. Unfortunately, many of the failure origins are lost upon fracture due to the large amount of elastic energy stored in the high-strength fibers. Nevertheless, there are some important observations and analyses that can be made. All

Fig. 3. Matching halves of a SEM fractograph of Hughes fibers
(A-770725-37b; B-770725-37a). These show that fracture features
"point" back to the origin (arrows) at the surface even though
the exact cause is unknown.

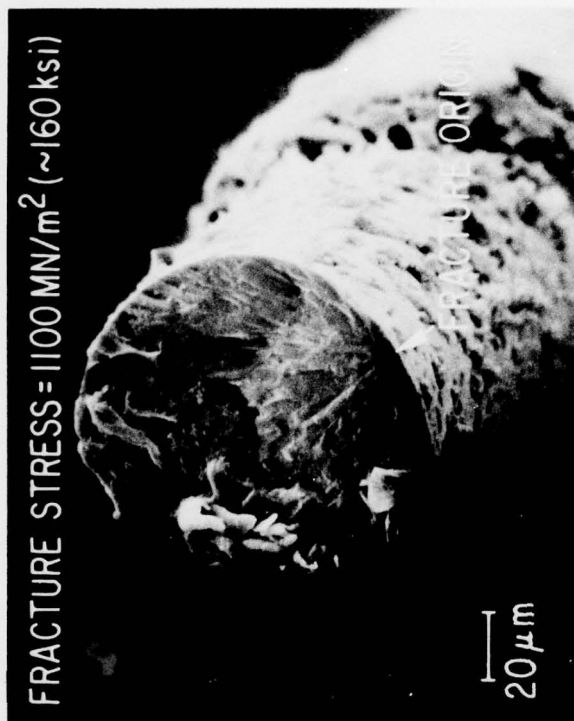
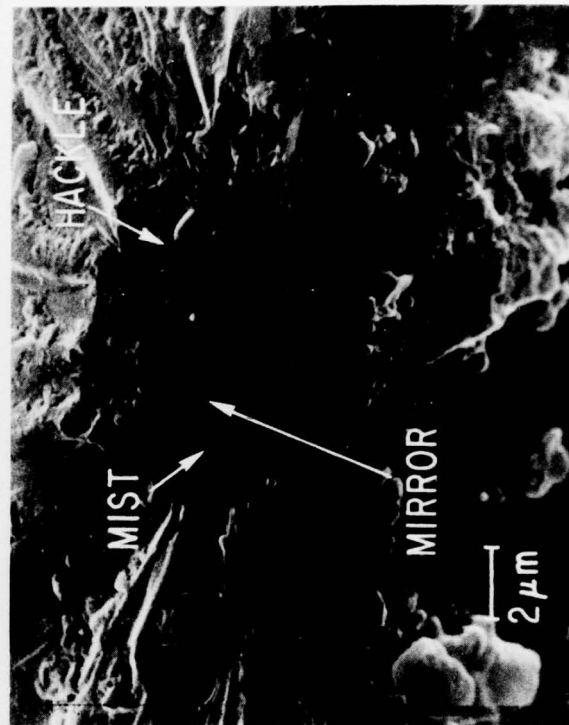
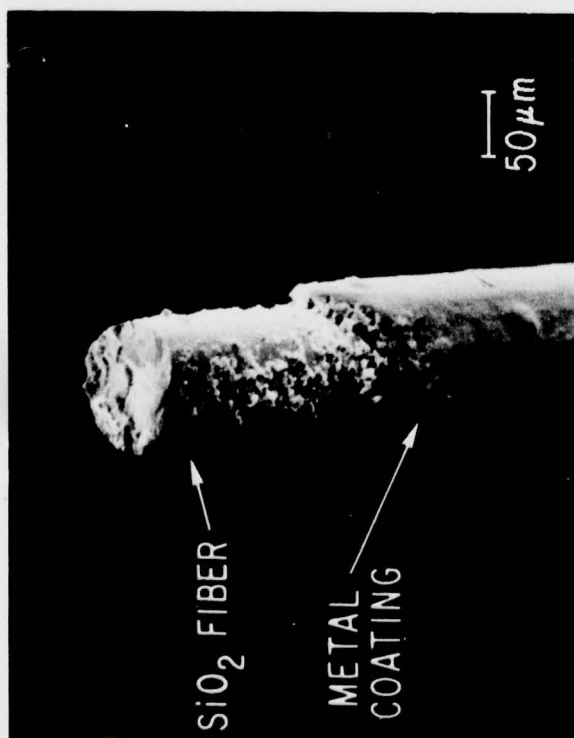
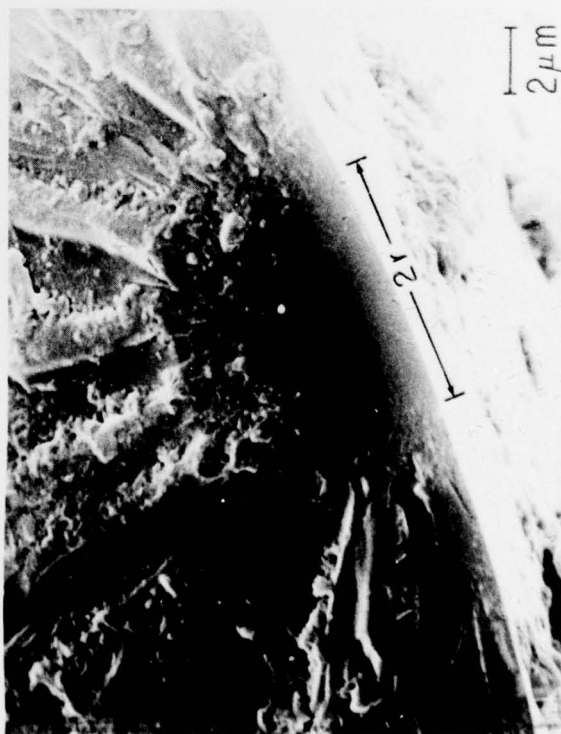
origins observed to date on Hughes fibers were from surface defects. These include a surface crack(Fig. 4) and a bubble which originated in the preform(Fig. 5). In the latter, the bubbles along the surface indicate that a large bubble in the preform was drawn out during fiber pulling. Even with the large defect (38 μm half-width) it's spherical shape resulted in approximately 160,000 psi(from mirror measurements) breaking stress in reasonable agreement with the approximately 200,000 psi measured during the test. Other origins were not found, but the fracture markings leading back to the surface on a few others could readily be observed as in Fig. 3. In fact, the fiber in Fig. 3A was etched in an aqua regia solution to remove the aluminum coating because it obscured the detail of the origin. Even then, the aluminum appeared coherently connected to the glass indicating that an aluminum oxide interface may be present between glass and metal. Delayed failure specimens 1 through 5 in Table I also showed a high degree of corrosion(Figs. 4 & 6), but the corrosion product has not yet been identified. As can be seen in Fig. 6 there are many cracks in the aluminum coating. Many of these cracks look like they follow the grain boundaries in the aluminum. This indicates that they could be occurring during stressing, although it is not clear that corrosion alone would not cause this. Also, it is possible that they are a result of stress corrosion cracking. One way of determining the cause of these cracks is to examine the fiber after coating and during stressing. In addition to the cracks there is evidence of roughly circular pits. One would suspect that the pits would be elongated if they occurred before or during stressing, and more circular or spherical if they occurred after stressing. Thus, one would surmise that these

Fig. 4. SEM fractograph of a Hughes fiber (770209 - H-SS-2) showing fracture demarcations surrounding the fracture origin (most likely a sharp crack-not visible on the surface).

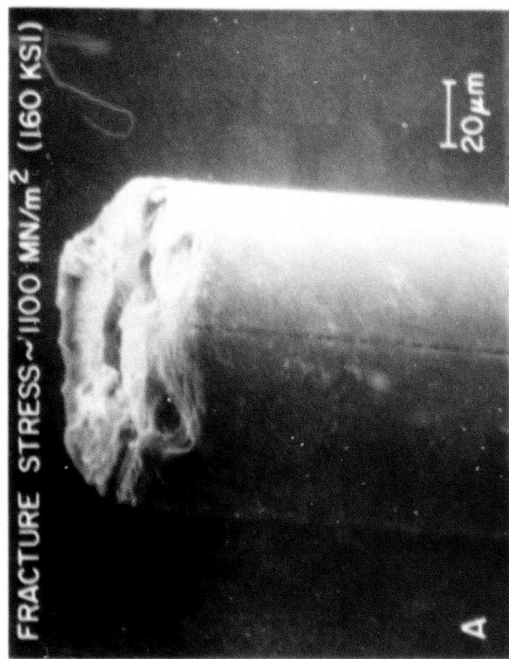
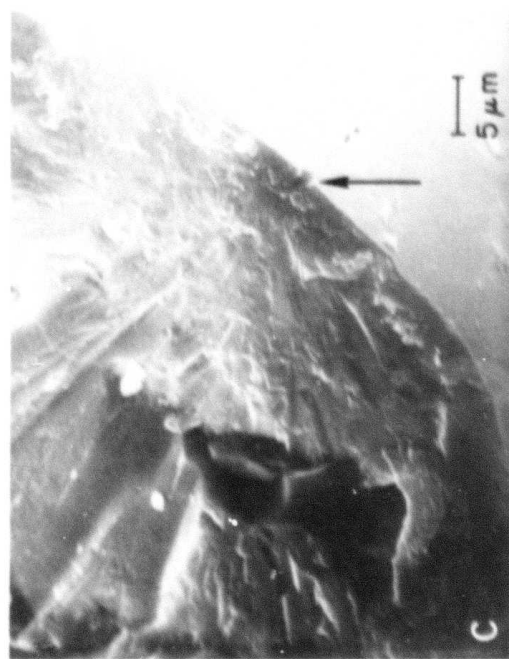
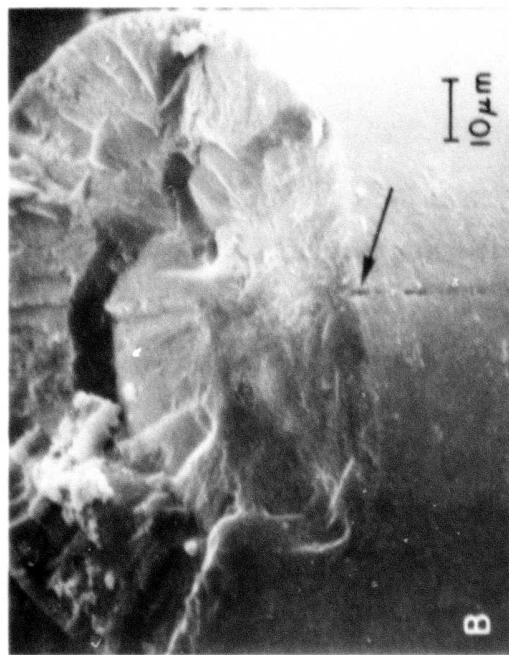
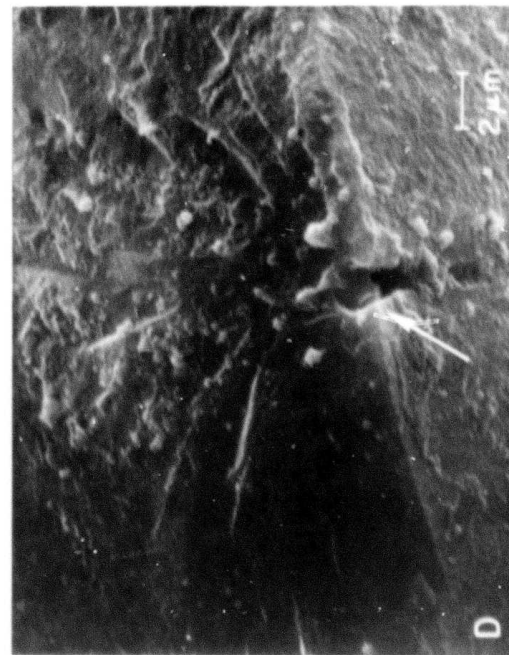
Fig. 5. SEM fractograph of a Hughes fiber (770209 - H-SS-5) after removal of the metal coating. Source of failure (arrow) is from an elliptical defect, most likely from a bubble in the preform that was drawn out with the fiber.

2. High quality glass should be used in all phases of the fiber process because the weakest link theory is applicable to fiber processing, e.g. a defect or bubble in the tube used in the CVD process could be transported to the final fiber.

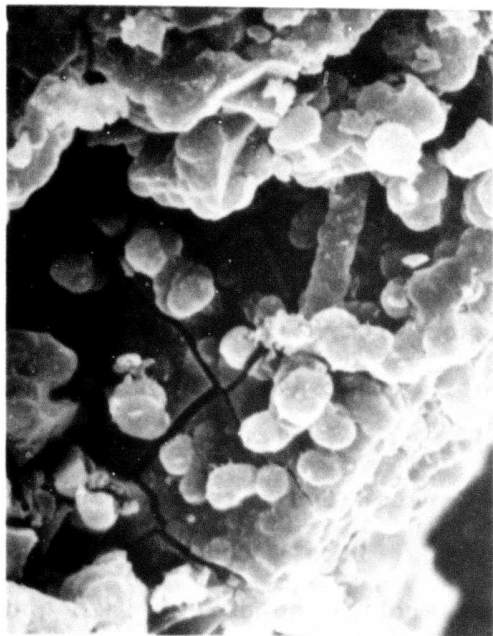
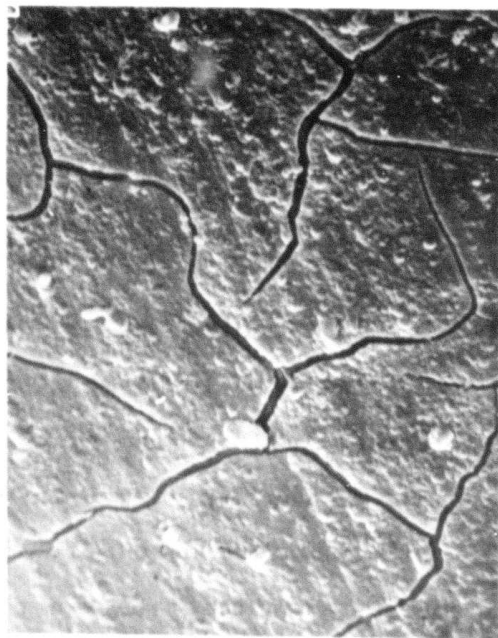
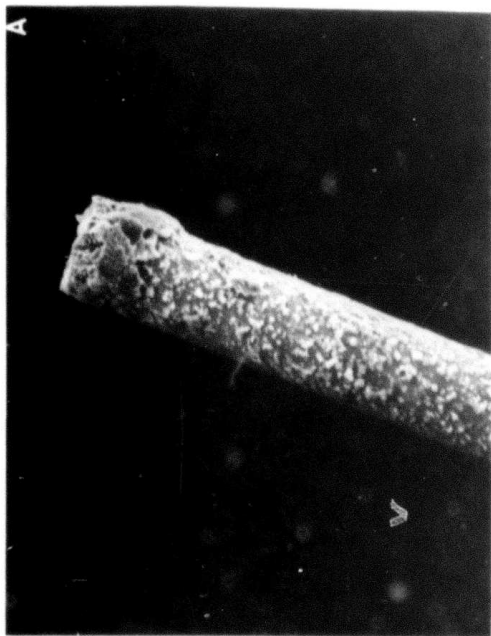
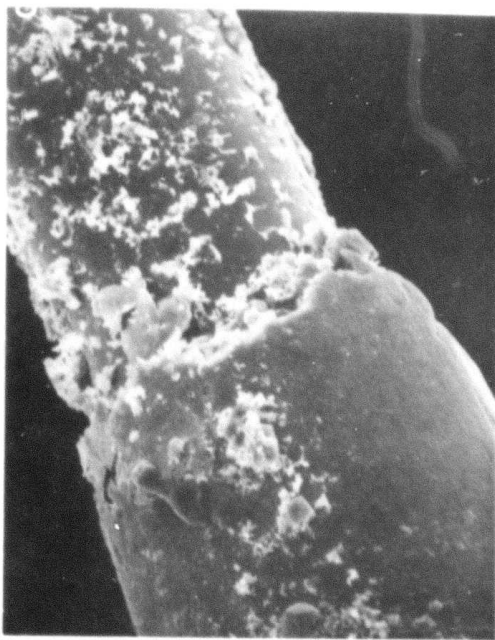
Fig. 6. SEM micrograph of the corroded surface of metal and fiber as a result of failure in salt water. (Hughes fiber 770209-H-SS-1). Notice the cracks in the metal tend to follow grain boundaries (C and D).

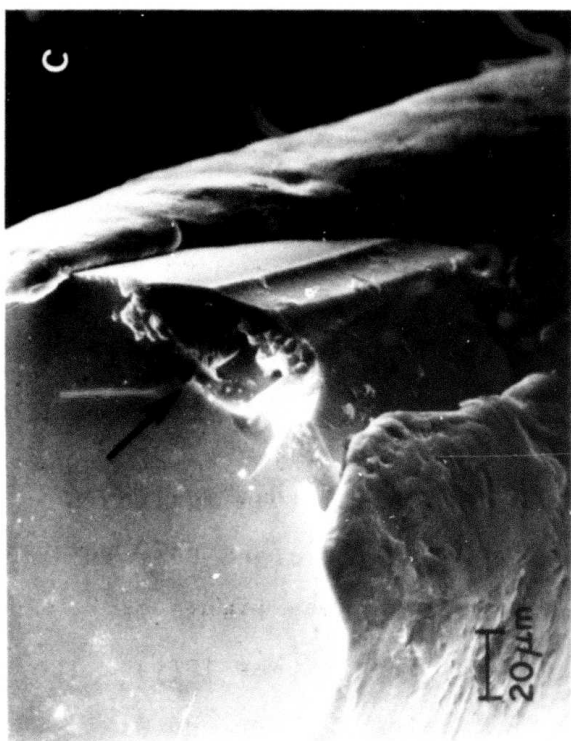
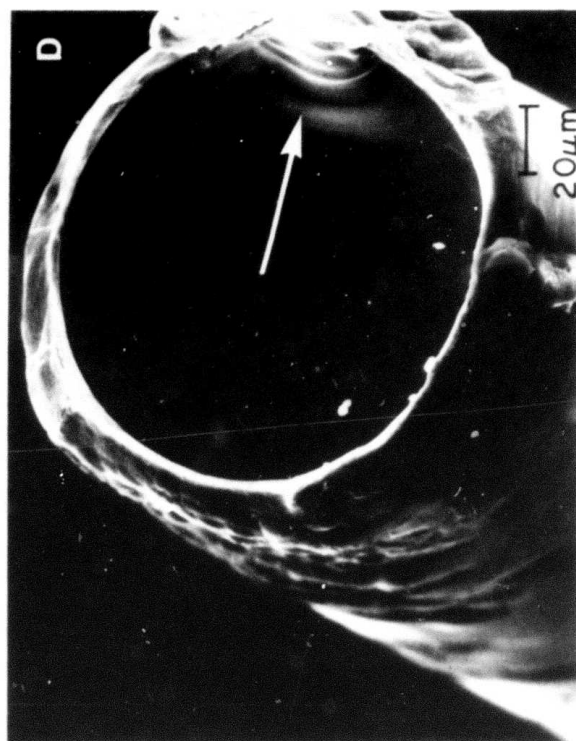
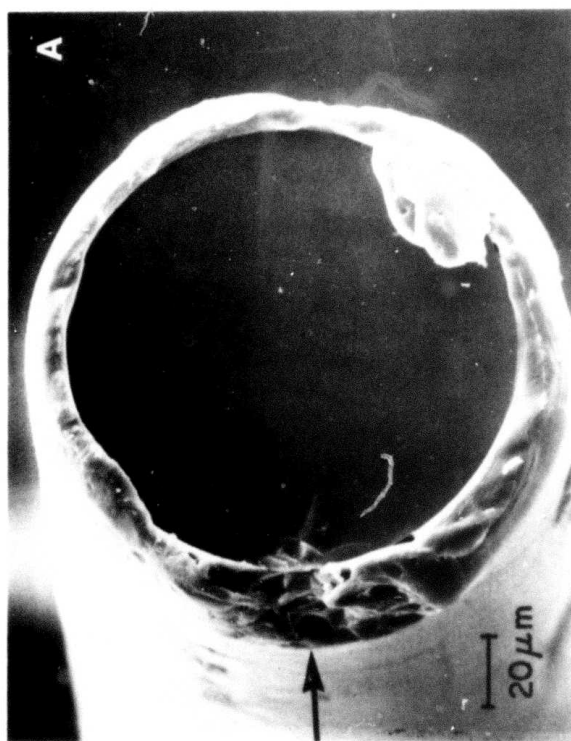
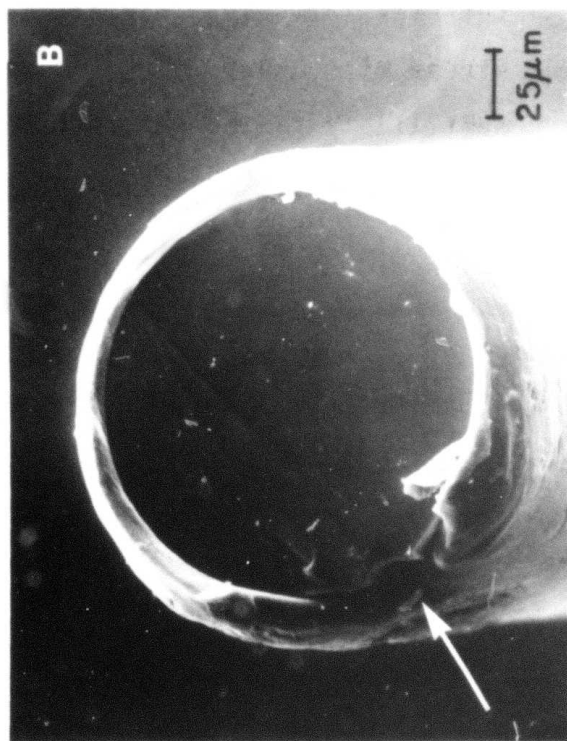
Several low strength fibers were sent from Hughes for identification of fracture origins. Although the analysis is not complete, it is quite evident that a semi-elliptical ridge on the surface of most of the fibers examined is consistently the cause of failure (Fig. 7). Because the ridge along the fiber surface is relatively smooth it would appear that this defect is being caused in the drawing process when the fiber is relatively hot. One would expect a rough gouge if some object were pulled across the surface. Further communication between NRL and Hughes will hopefully trace the exact cause of this defect and thereby eliminate it.

Fig. 7. SEM fractograph of four Hughes fibers failed in proof test at relatively low strengths. Notice that all fibers indicate surface failure from an elliptical cut with ridge. The smoothness of the depression in B and C would indicate this occurred while the fiber was soft. Also, most likely the metal is debonded from the fiber in the area around the defect in B and C. (770725-: A-4a; B-2a; C-1a; D-3)

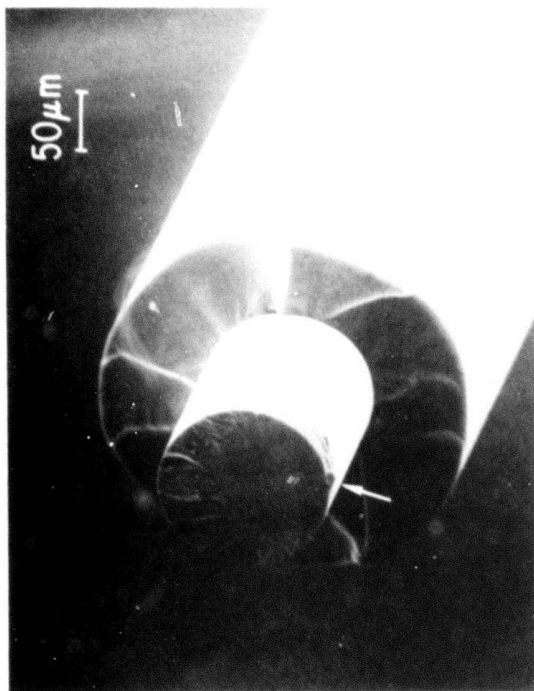
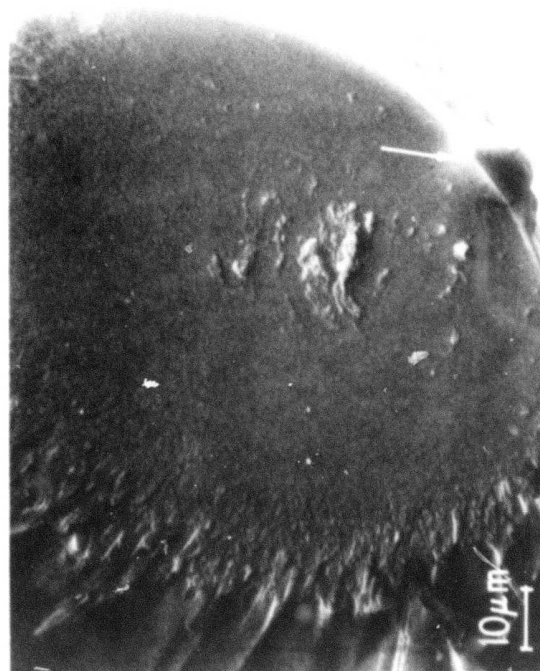
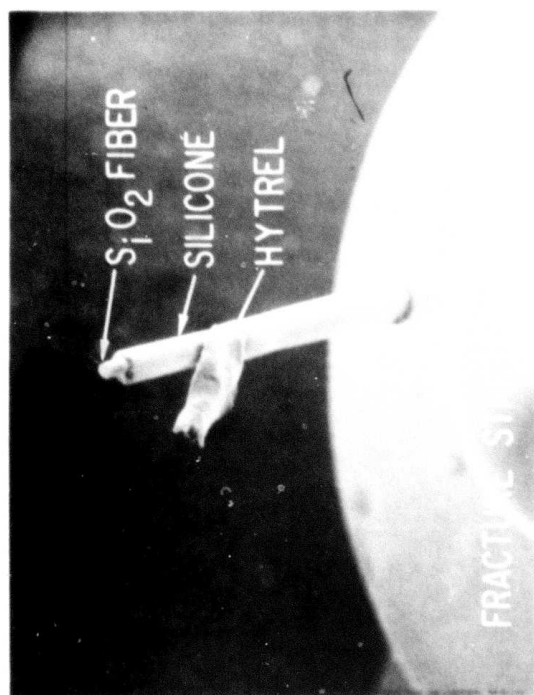
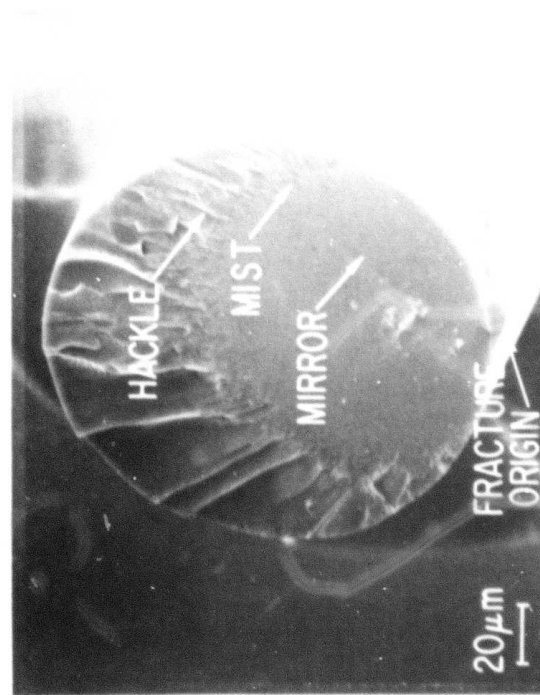
The surface failures were a result of a foreign particle (Fig. 8), five from cracks or mechanically induced chips (e.g. Fig. 9 and 10), and 5 "unidentified" sources of failure (e.g. Figs. 11 and 12). It is suspected that at least four of the last 5 listed are from small crystallite formations, but this has to be determined for certain.

A foreign particle is shown attached to the silica in Figures 8 and 13. The particle was analyzed using an electron microprobe; the results indicated the presence of magnesium and iron as well as silica (Fig. 13). This type of failure can be avoided by filtering (clean room). This "dust" particle which attached to the fiber during drawing caused a small (approximately 1.5 μm) crack, most likely upon cooling, which subsequently lead to failure. The size of this crack (2 μm) is in

good agreement with the calculated $3\text{ }\mu\text{m}$ from Eq. 2.

Fig. 8. SEM fractograph of an ITT fiber (761221-4) that failed in a proof test (200 ksi). The source of failure (crack between foreign particle and bulk SiO_2 , as shown in lower right) is shown surrounded by the fracture demarcations (lower left). The foreign particle is identified as containing Mg, Fe, and Si (cf Fig. 13). The 'mirror' size measurements indicate a failure stress of $\sim 315 \text{ MN/m}^2$ ($\sim 45 \text{ ksi}$). This means that this fiber most likely failed before the full proof stress was achieved, i.e. around the edge of the drum.

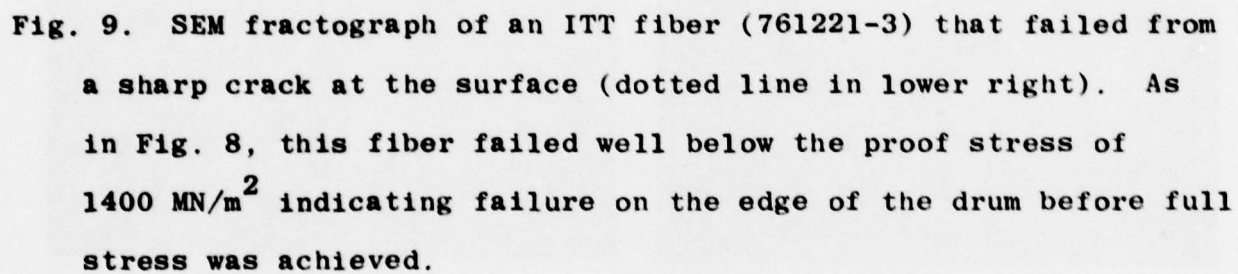
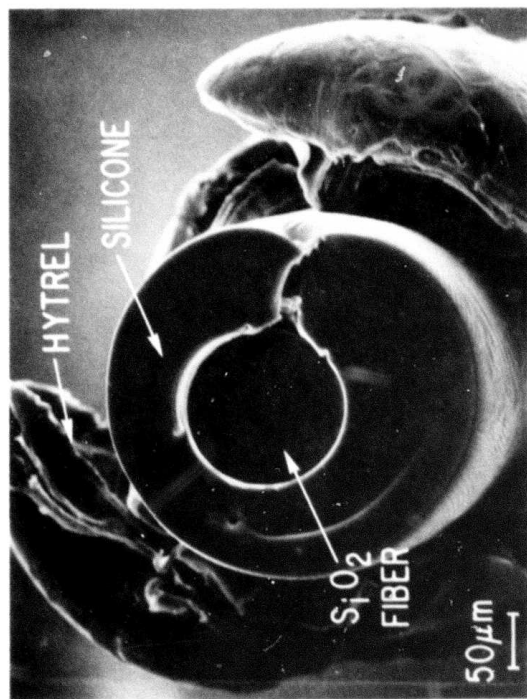
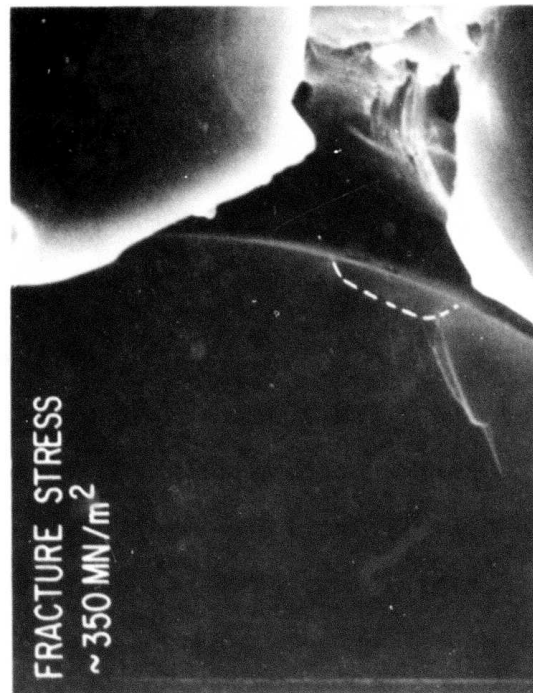
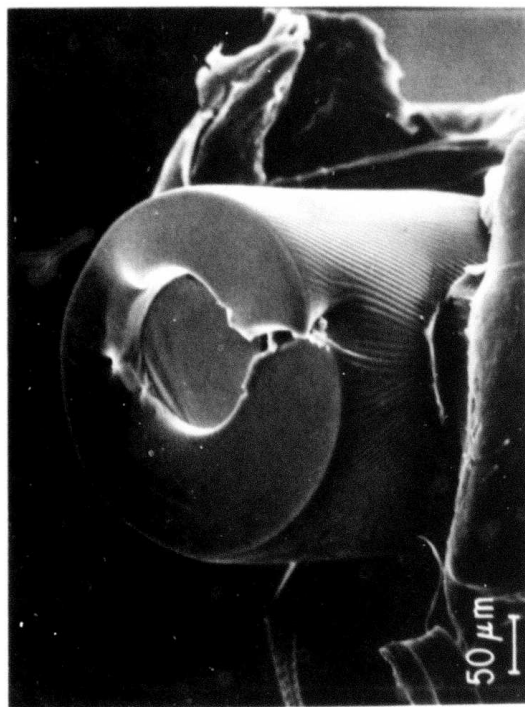
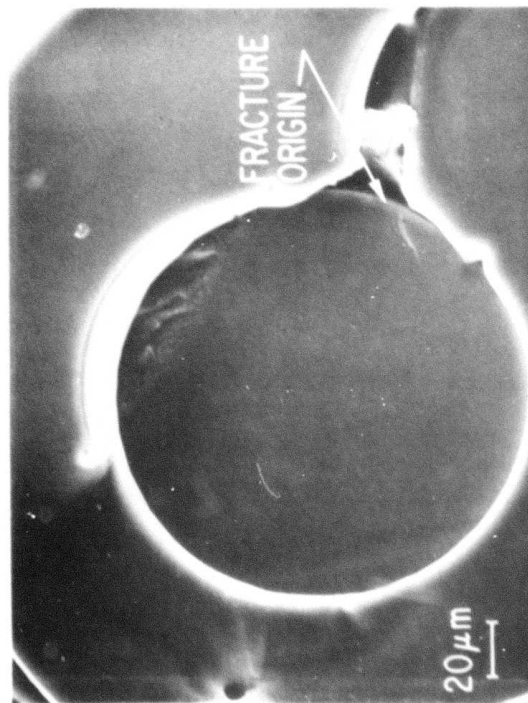
Fig. 9. SEM fractograph of an ITT fiber (761221-3) that failed from a sharp crack at the surface (dotted line in lower right). As in Fig. 8, this fiber failed well below the proof stress of 1400 MN/m^2 indicating failure on the edge of the drum before full stress was achieved.

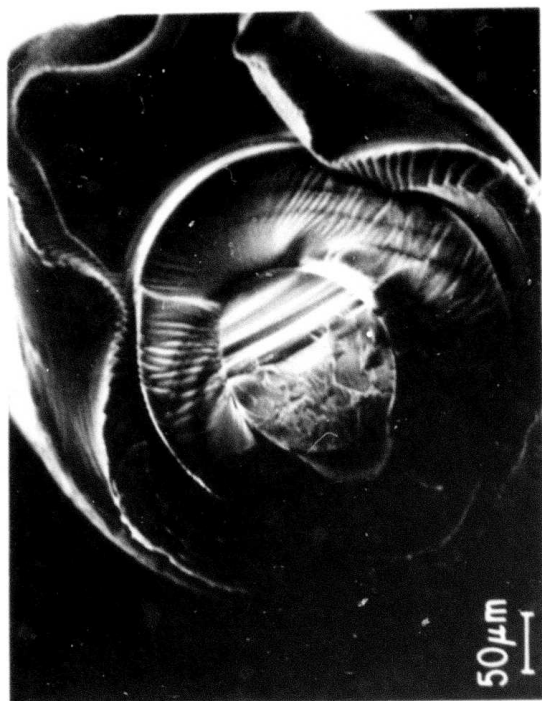
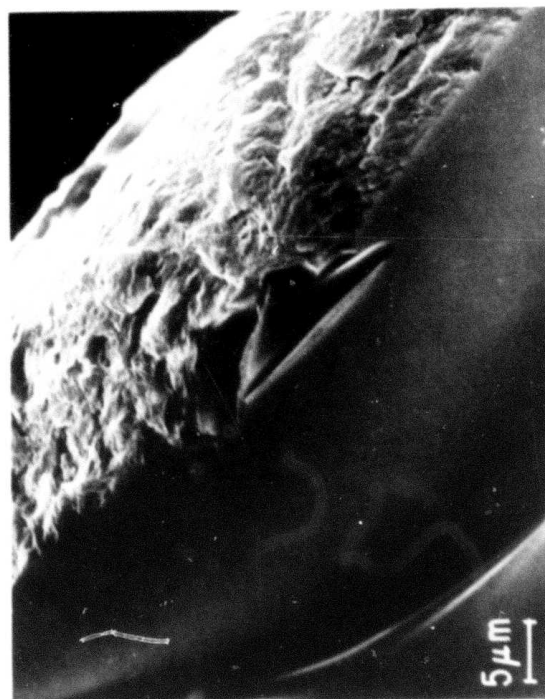
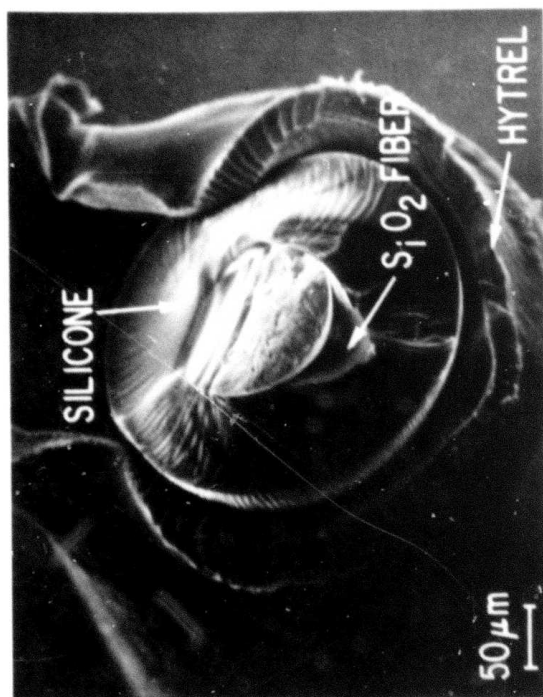
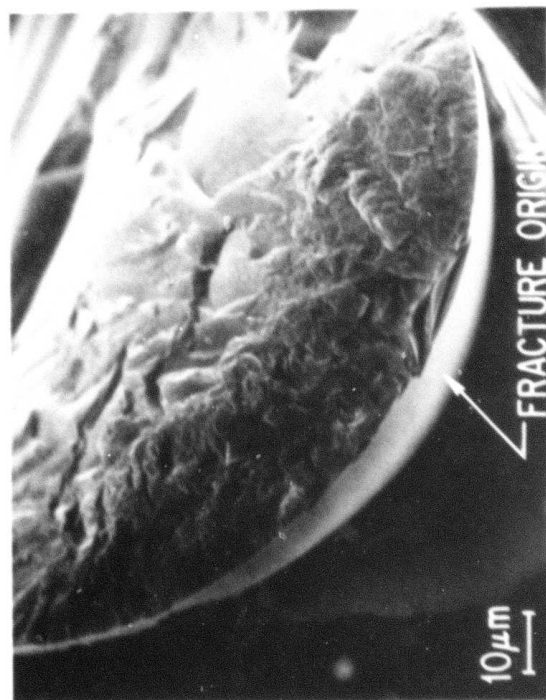
Fig. 10. SEM fractograph of an ITT fiber (761221-5) that failed from a mechanically induced crack. Although the crack is relatively large, it is probably not sharp, and thus, this fiber most likely achieved the 1400 MN/m^2 proof stress.

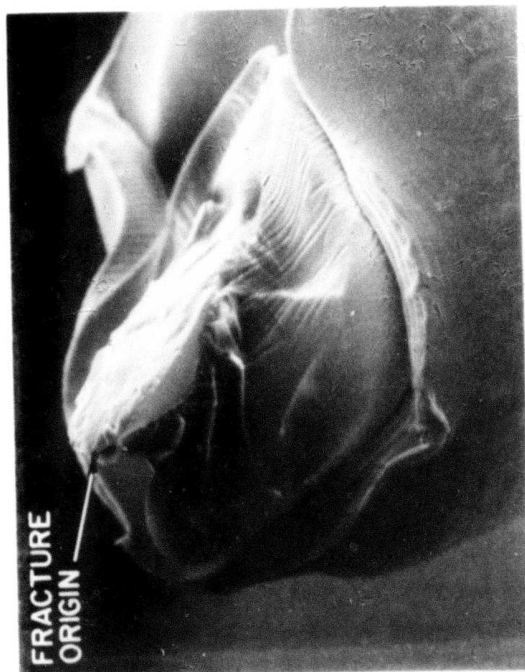
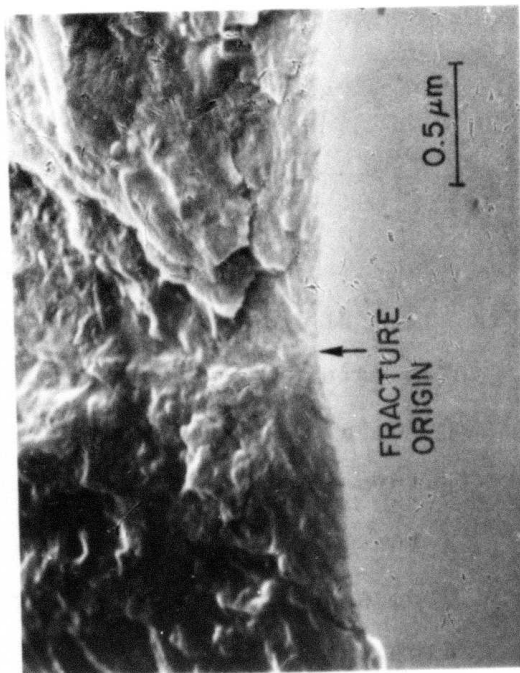
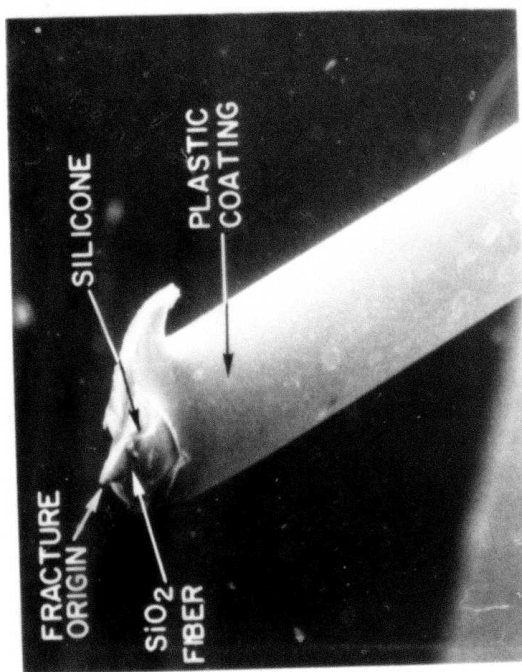
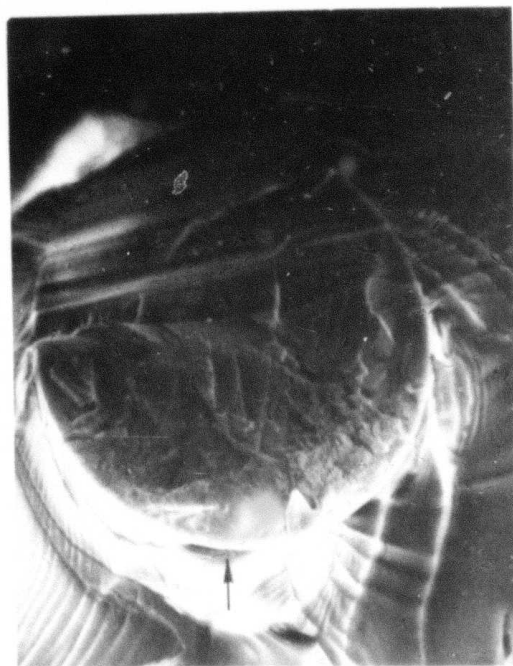
Fig. 11. SEM of an ITT fiber (770209-A) failing from the surface. The nature of the fracture origin and surrounding area (rough surface) indicates a high stress ($> 2100 \text{ MN/m}^2$). The exact source of failure is unknown.

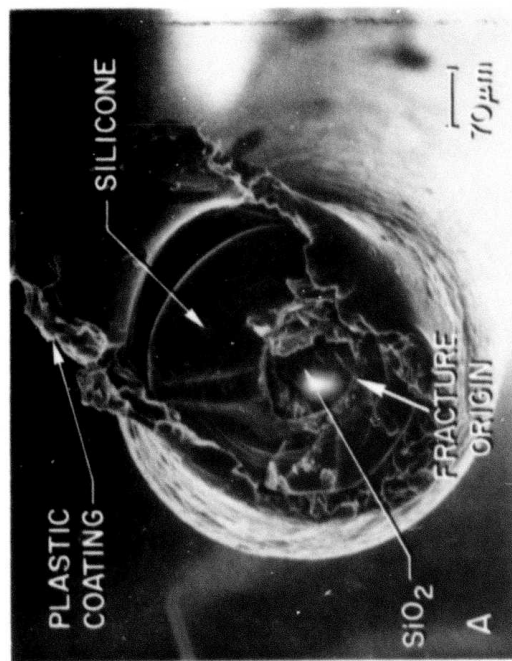
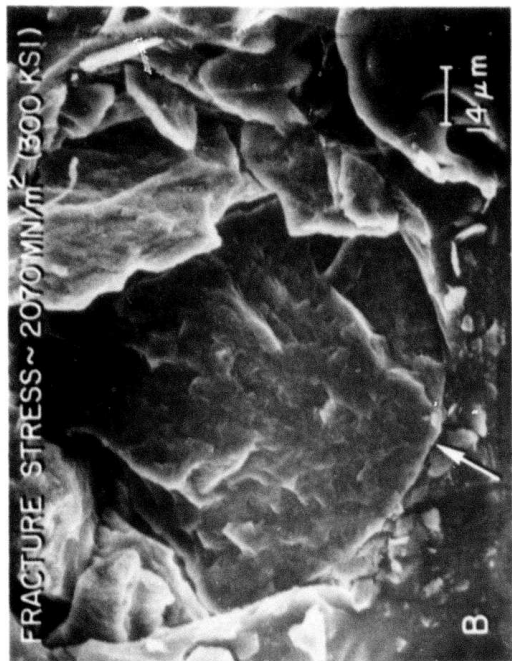
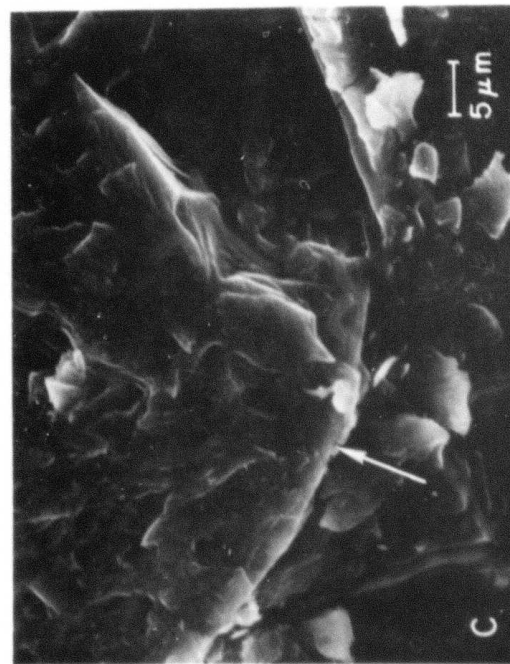
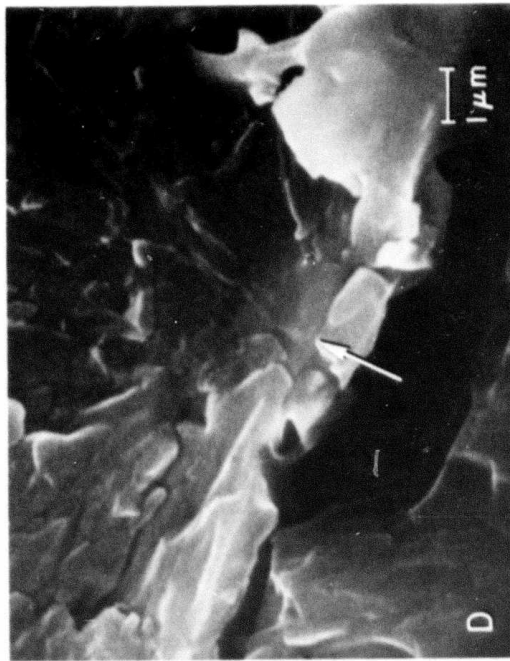
Fig. 12. SEM of an ITT fiber (770209-1) failed from the surface.

The nature of the rough area surrounding the origin (arrow in B, C, and D) indicates a high stress ($\sim 2070 \text{ MN/m}^2$). The exact nature of the fracture origin is unknown, but could be due to a thermal expansion mismatch between two phases (i.e. glassy SiO_2 and crystalline SiO_2 or crystalline metal or crystalline alumina).

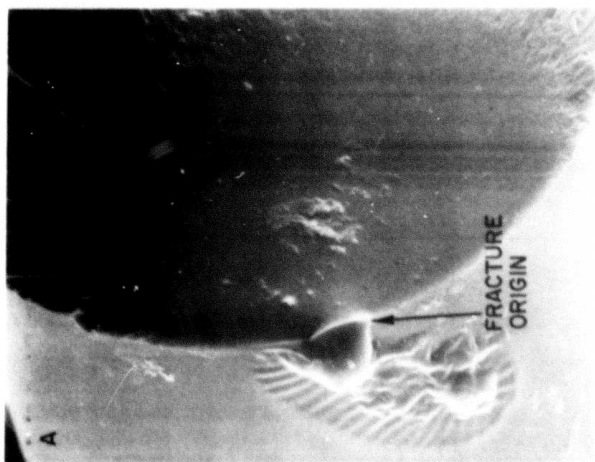
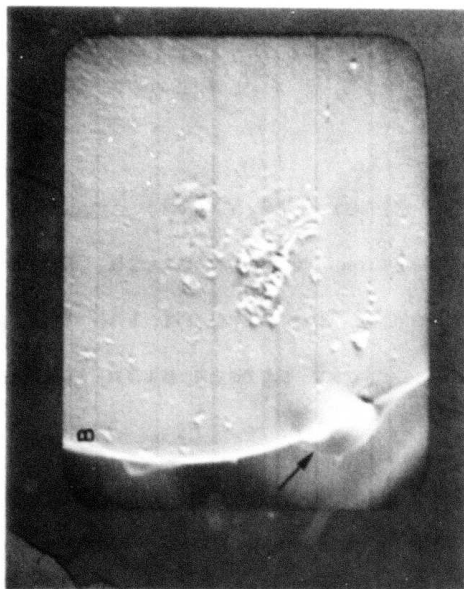
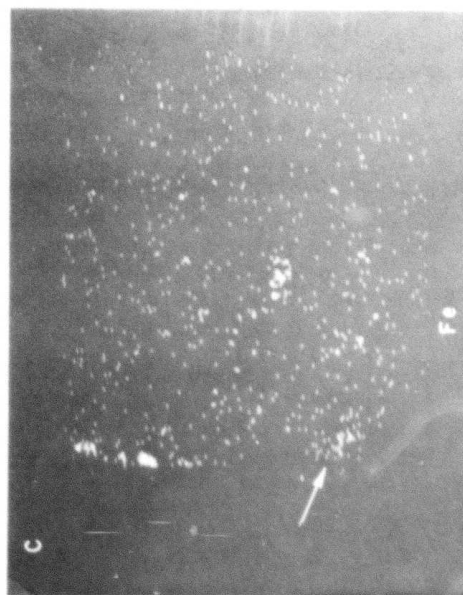
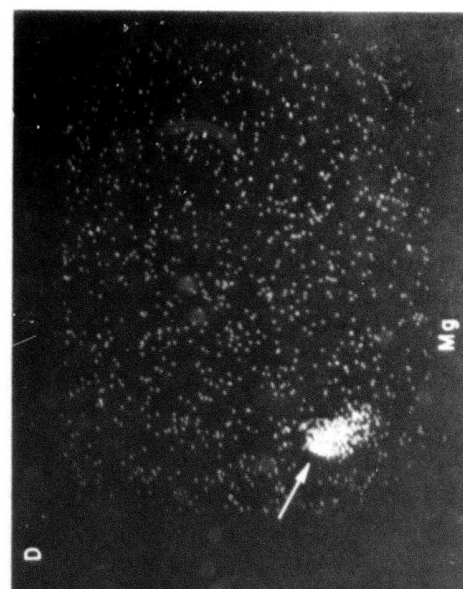
Fig. 13. A) SEM fractograph of Fig. 8 for reference. B) Real image of A as given by microprobe unit. C and D) Microprobe electron images showing relative concentrations of Fe and Mg, respectively. Arrows indicate fracture origin for reference.

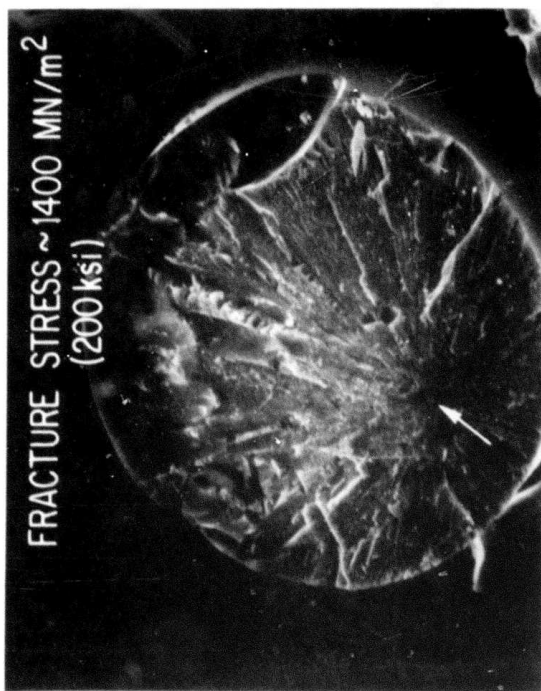
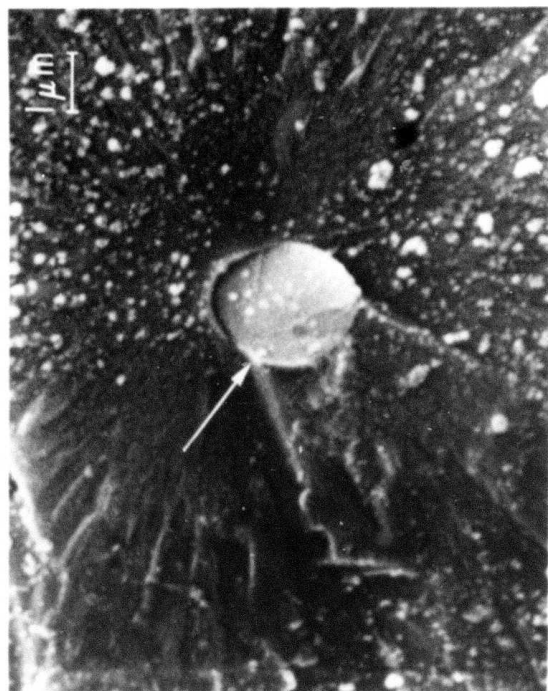
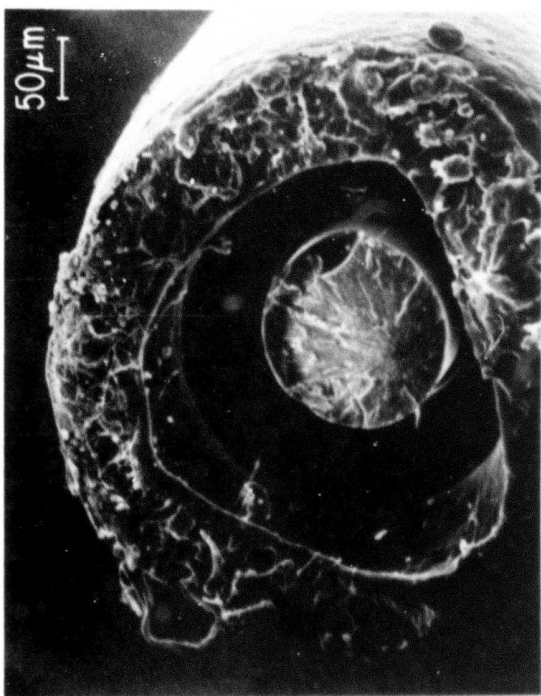
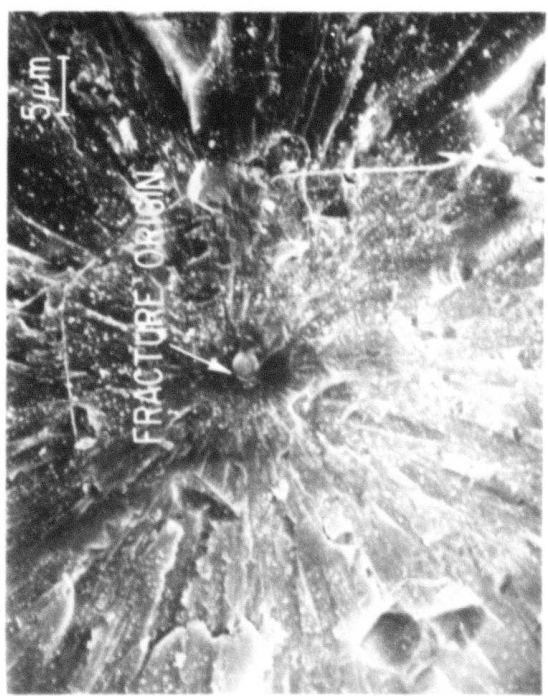
Although most fractures were from surface origins, there are seven cases where internal origins occurred. One internal origin was an inclusion containing rare earth elements (Nb and La) Fig. 14. This failure occurred due to a ($0.2\text{ }\mu\text{m}$) crack formed between the inclusion and bulk SiO_2 . Failure from inclusions related to natural forming elements can most likely be eliminated by using synthetic quartz material rather than the natural quartz. This also applies to preform manufacture used in the CVD process. If the outer tube or preform material is natural quartz, then defects such as bubbles and inclusions will be transferred to the final silica fiber. Closer examination is planned to determine the source of these internal failures. Higher magnification is required to determine the source of these failures because the size of the defect, in most cases, is less than $0.2\text{ }\mu\text{m}$, and consequently detailed analysis is difficult.

Fig. 14. SEM fractograph of an ITT fiber (761221-2) showing failure from a crack at the interface between a rare earth (Nb and La) inclusion and the bulk SiO_2 fiber. The size of the fracture "mirror" region surrounding the origin agrees with the 1400 MN/m^2 proof stress recorded.
